Milwaukee County Needs to Commit to a Preventive Repair & Maintenance Program to Ensure Public Safety

October 2010

Milwaukee County Department of Audit

We have completed an audit of Milwaukee County's efforts to maintain buildings in a manner that ensures the safety of the public and County employees.

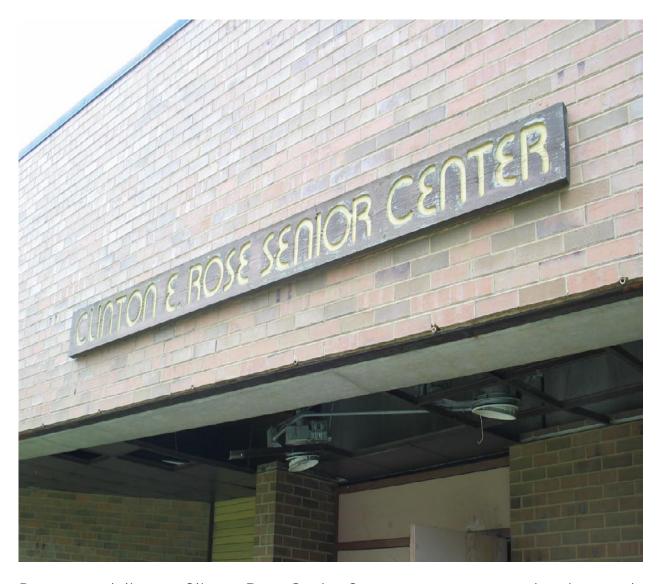
Clinton Rose Park Senior Center

Due to vandalism at Clinton Rose Senior Center a rear entrance has incurred damage with ceiling tiles missing exposing electrical light fixtures that hang down and the front entrance has loose tiles.

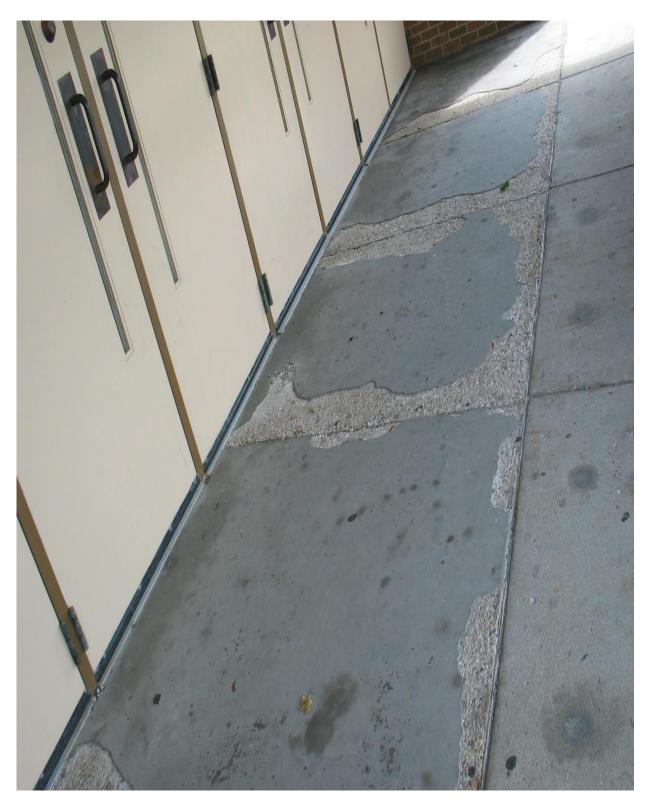
Clinton Rose Park Senior Center

Broken concrete floor slabs at the main entrance create a potential tripping hazard.

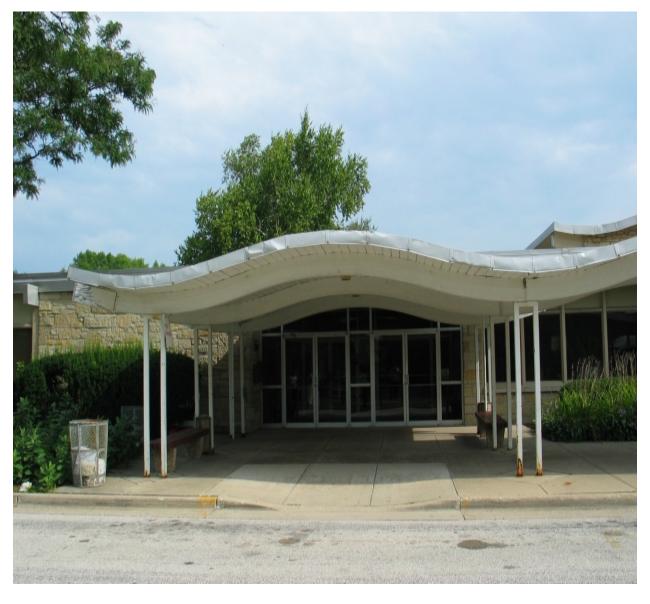
Washington Park Senior Center

The original overhead canopy structure covering entrance doors appears unsafe because of severe dry rot deterioration.

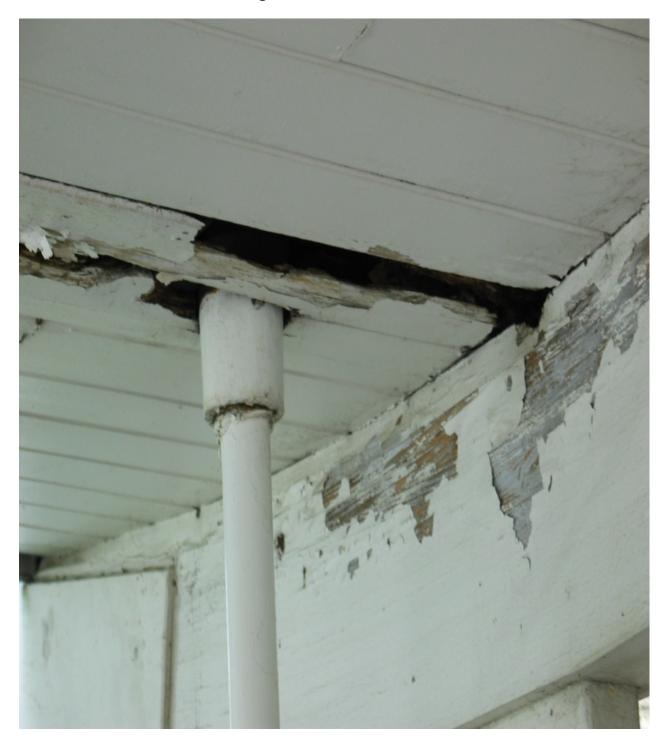
Washington Park Senior Center

The Canopy has visible large holes that have rotten through the surface and appears unsafe for visitors entering or exiting the building.

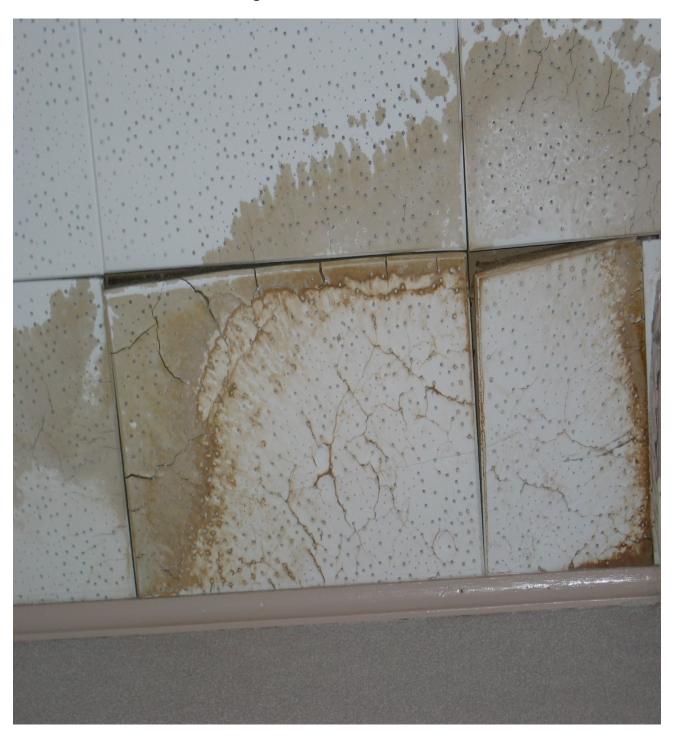
Washington Park Senior Center

Rainwater also enters the building through the roof in several different locations.

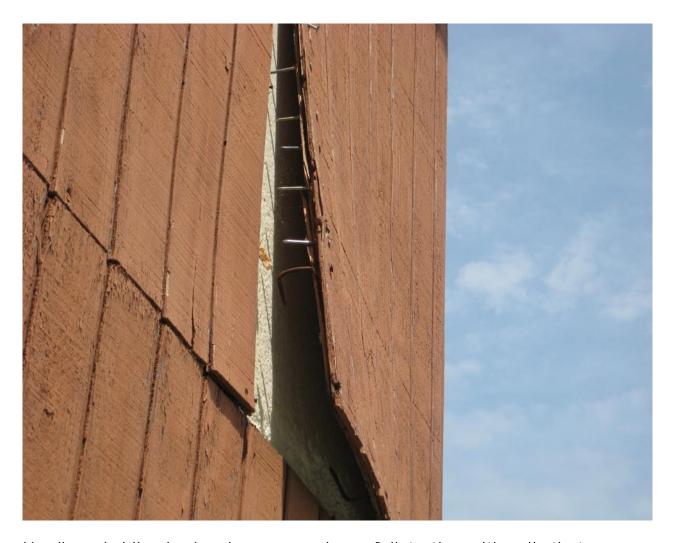
Wilson Park Senior Center

Hardboard siding is showing severe signs of distortion with nails that are literally detaching off the structure of the building. The loosely-pressed hardboard is susceptible to extreme swelling and buckling and can cause serious damage.

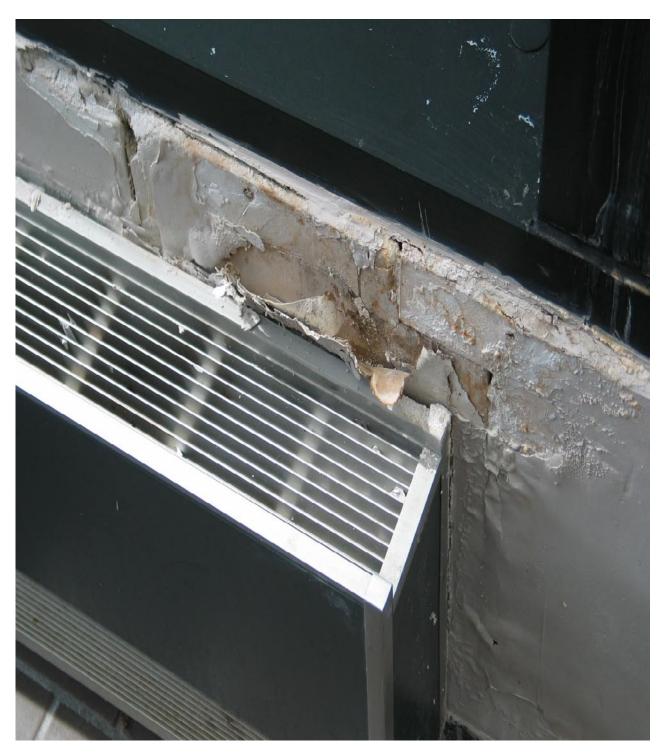
Wilson Park Senior Center

The main hall is experiencing water leakage from window due to weather stripping and sealing problems.

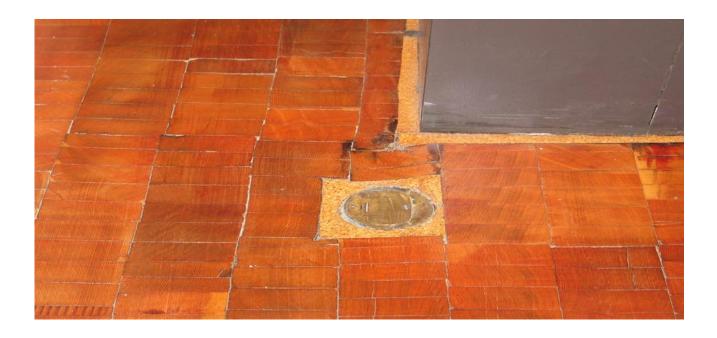
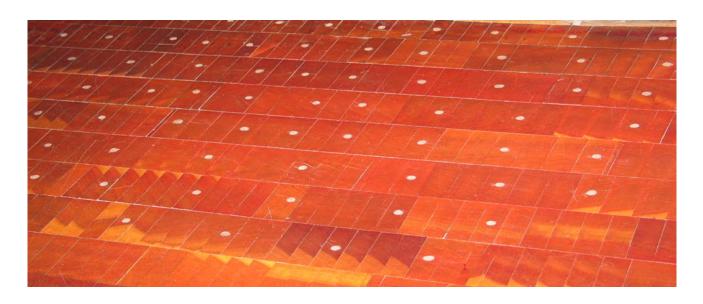
War Memorial

Severely warped floors some of the warped flooring has been nailed down to prevent reoccurrence.

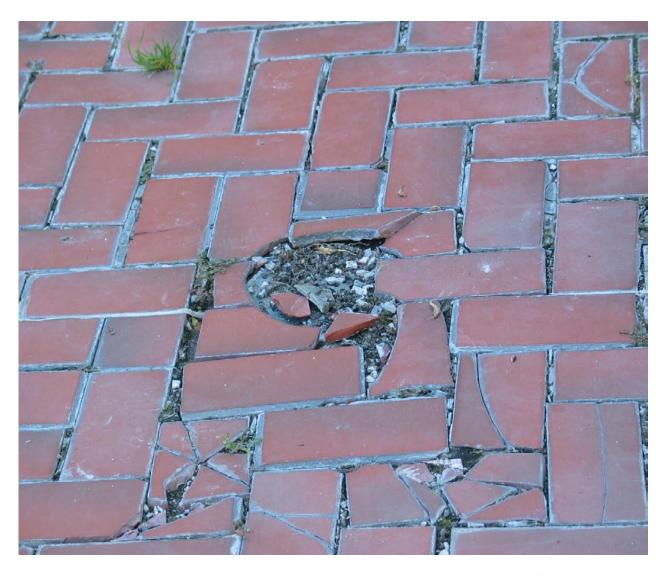
Villa Terrace Decorative Arts Museum

Villa Terrace has loose bricks on the east terrace and Mercury Courtyard that are deteriorating, popping up and cracked, which could have the potential to be unsafe for visitors due to the risk of accidents that could occur.

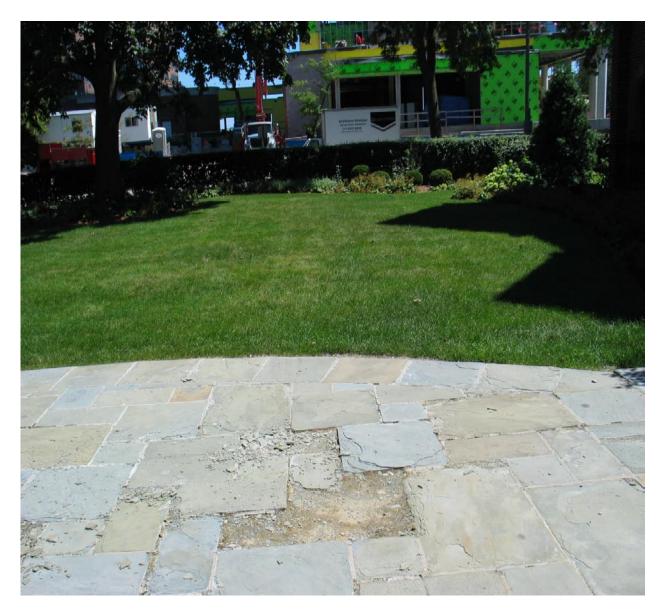
Charles Allis Art Museum

The Great Hall patio has missing, deteriorating, and cracked blue stone bricks and has the potential to be unsafe for visitors.

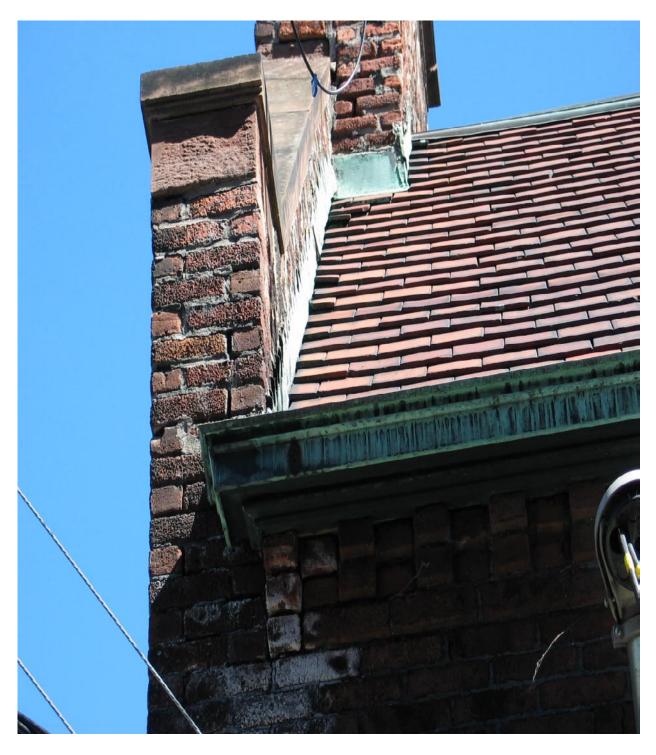
Charles Allis Art Museum

The roof and chimney area has bricks that are loose that needs tuckpointing, which could present a potential accident if the bricks would fall down on the public walking or standing underneath.

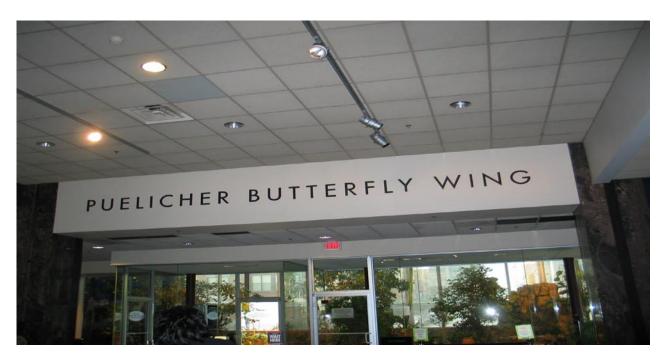
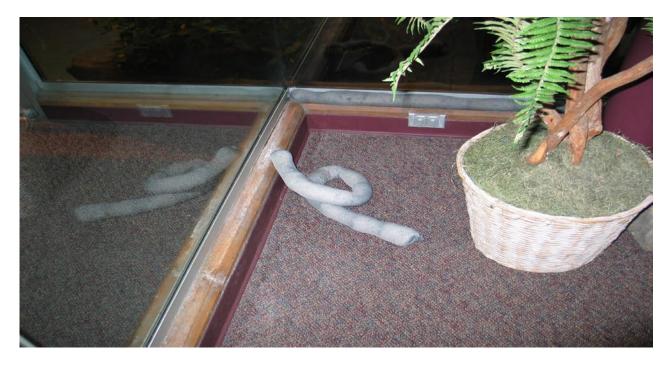
Milwaukee Pubic Museum

Rain also enters the Pulicher Butterfly Wing where the staff has placed water socks on window displays to catch rainwater.

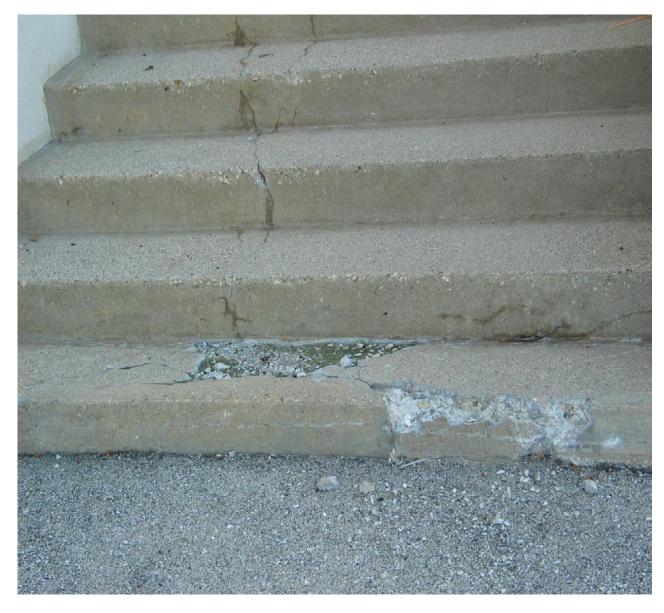
Park Administration

The outside staircases are in poor condition at Parks Administration Building the rear exit staircase show evidence of decaying.

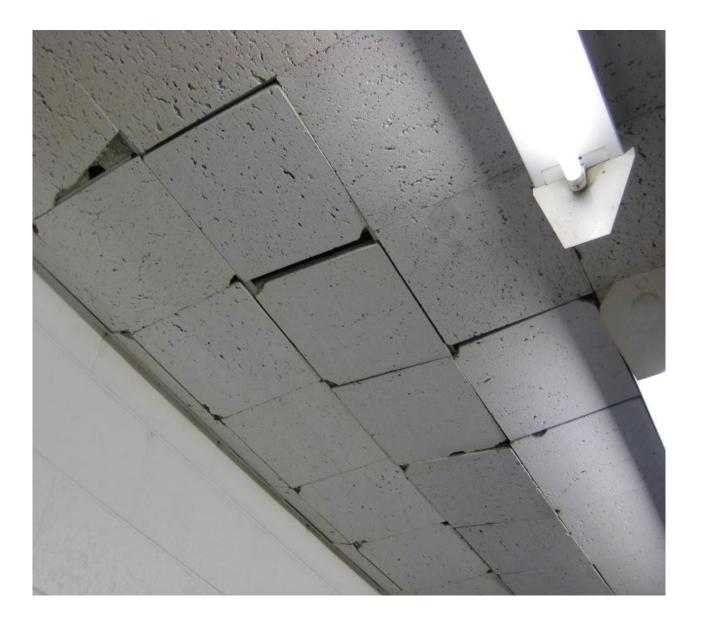
Milwaukee County Zoo - Zoofari Conference Center

The Zoofari Conference Center has sagging ceiling tiles that are on the verge on failing, which needs immediate attention because they are over the heads of visitors, before an accident occurrence.
